Cable Plan

Sequence Number: 243875494

Mains Cable Plan

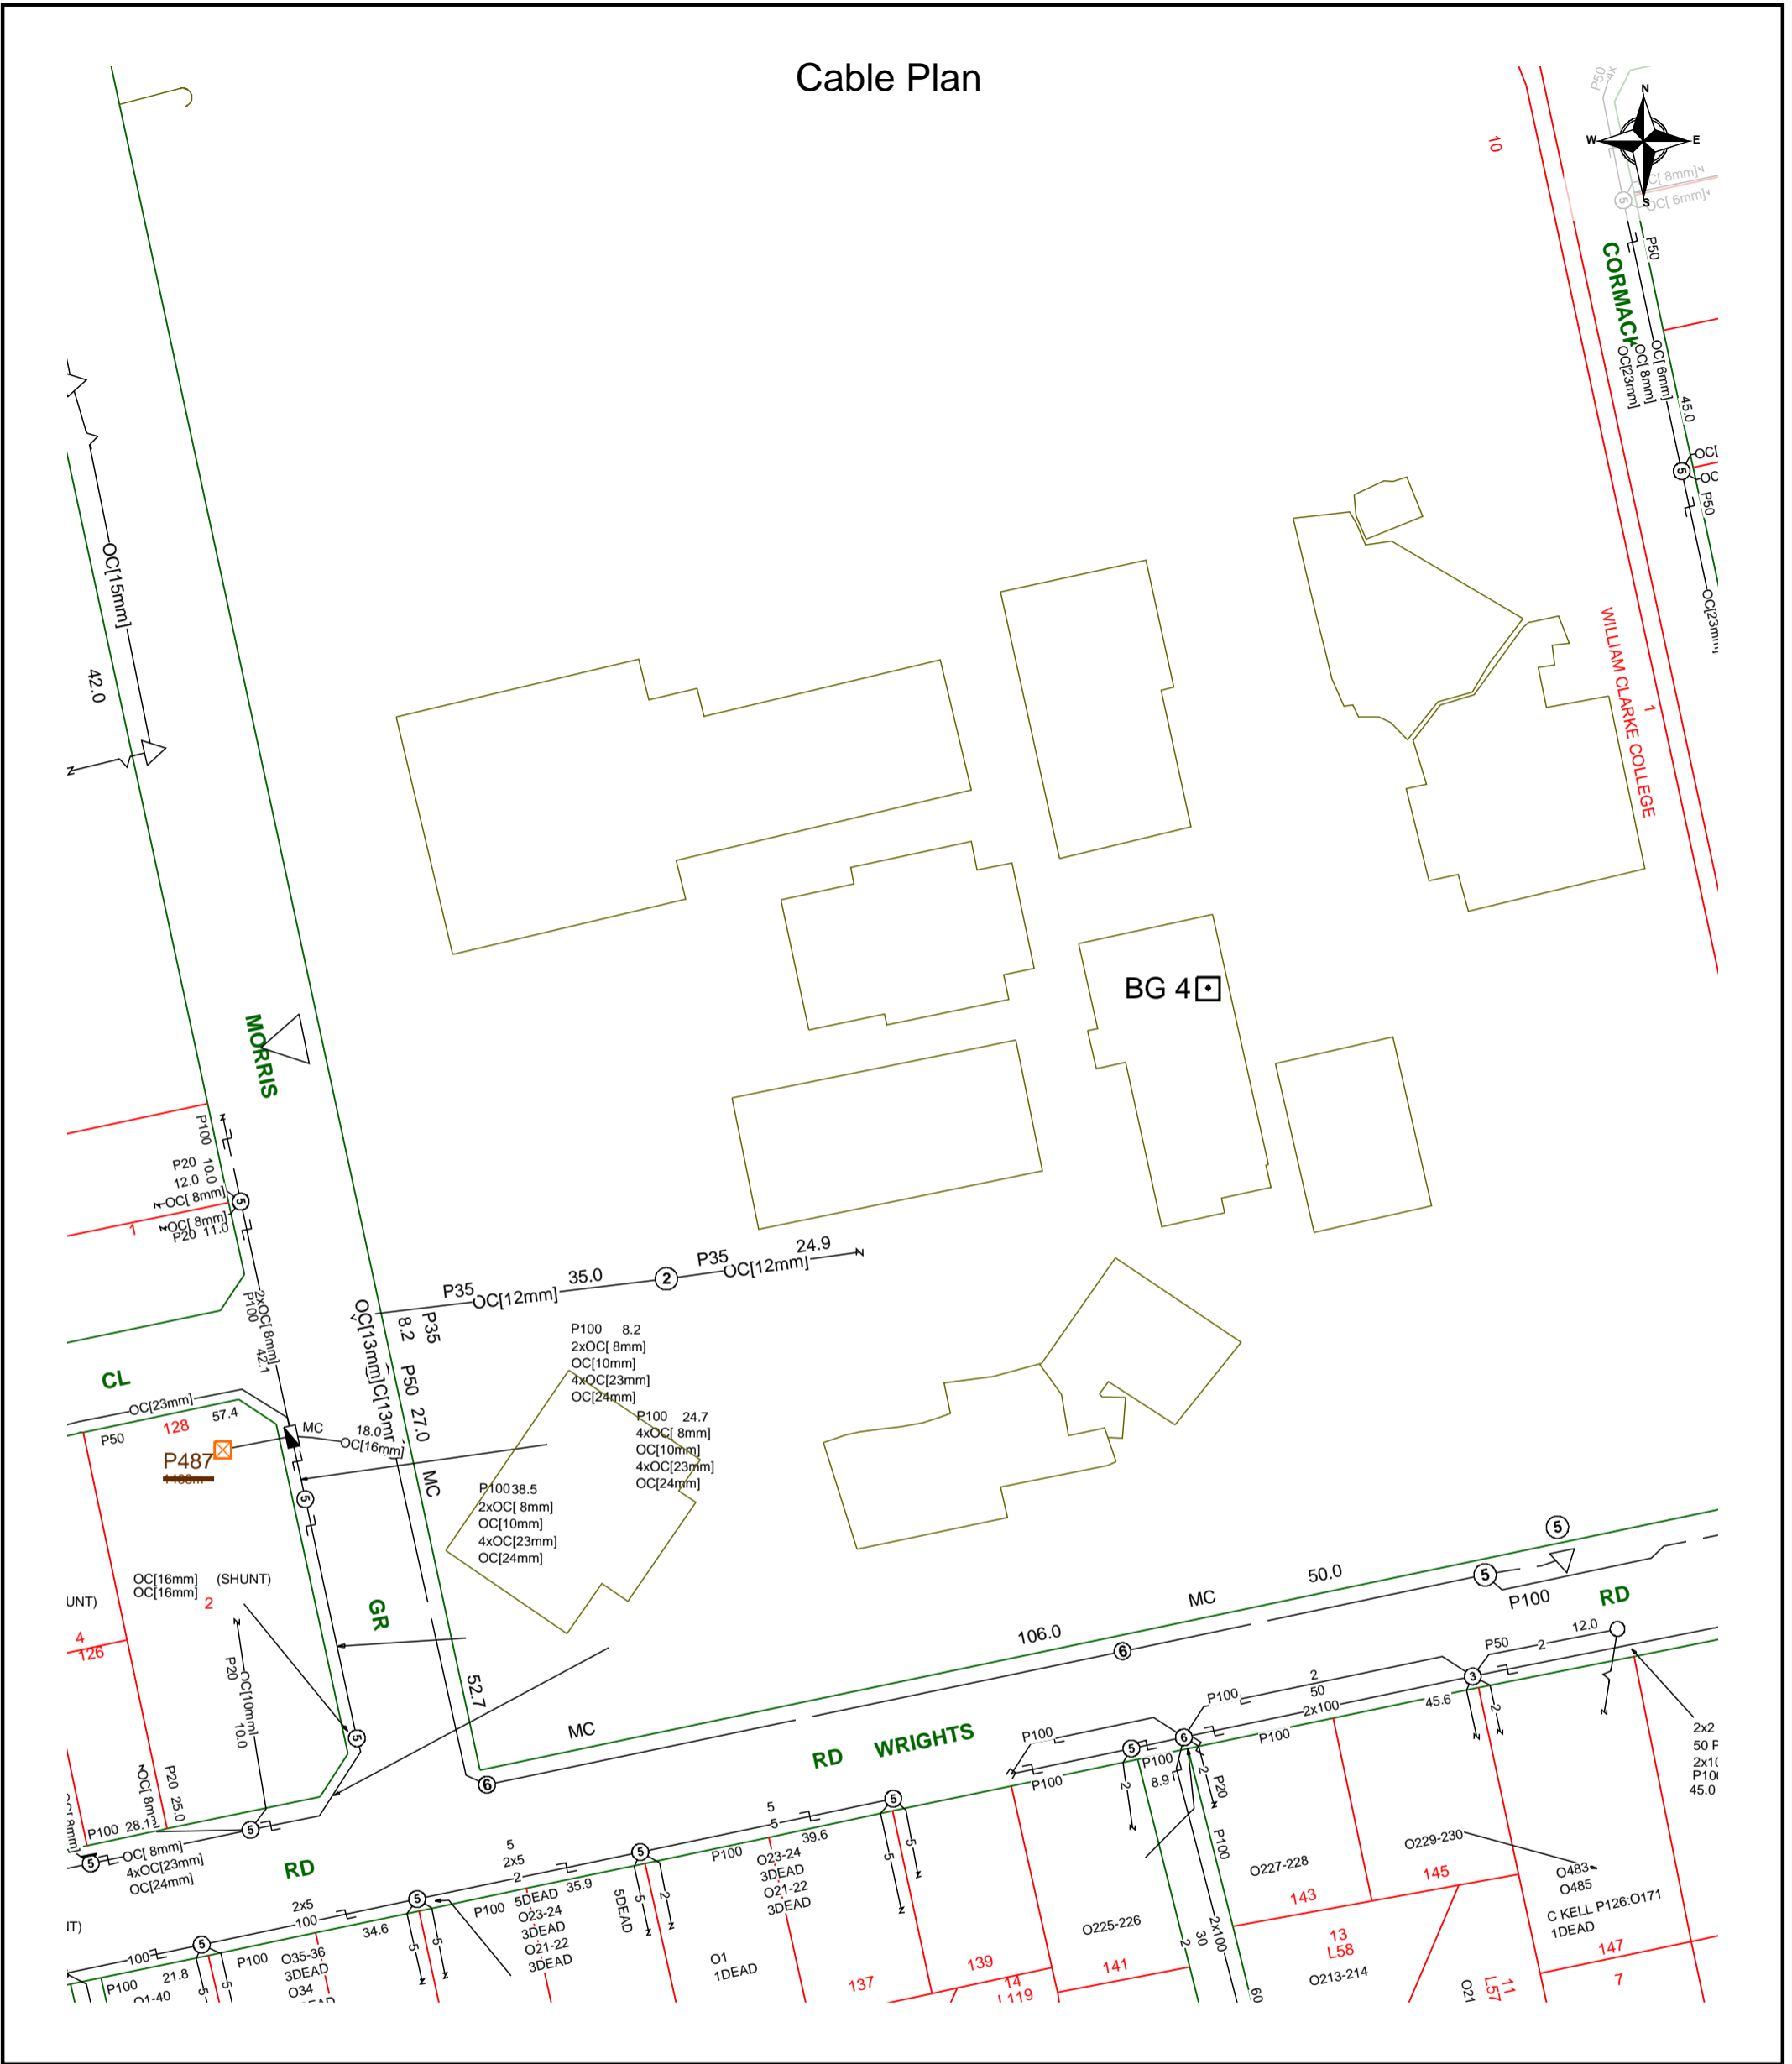
The above plan must be viewed in conjunction with the Mains Cable Plan on the following page

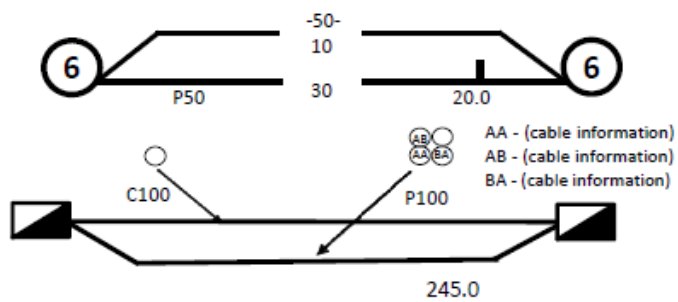
One 50mm PVC conduit (P50) containing a 50-pair and a 10-pair cable between two 6-pits, approximately 20.0m apart, with a direct buried 30-pair cable along the same route

Two separate conduit runs between two footway access chambers (manholes) approximately 245m apart A nest of four 100mm PVC conduits (P100) containing assorted cables in three ducts (one being empty) and one empty 100mm concrete duct (C100) along
